Afternoon Panel
Discussion Conference
for Advancing AML
Cleanup...With or
without Good Sam
Legislation

Jason Willis, P. E.

CO AML Program Manager

Site Characterization - Evans Gulch Water Quality

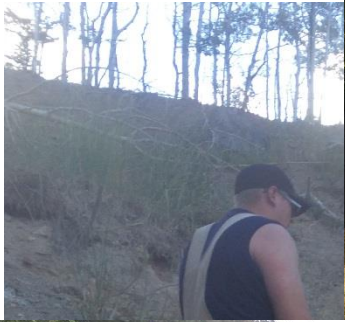
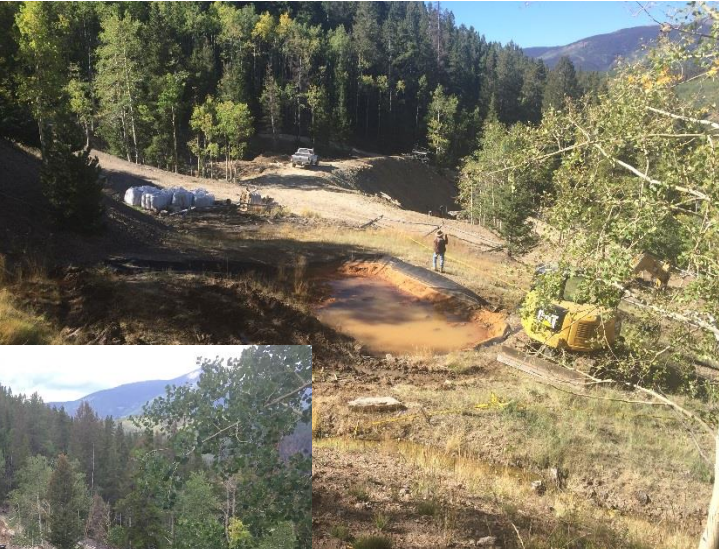
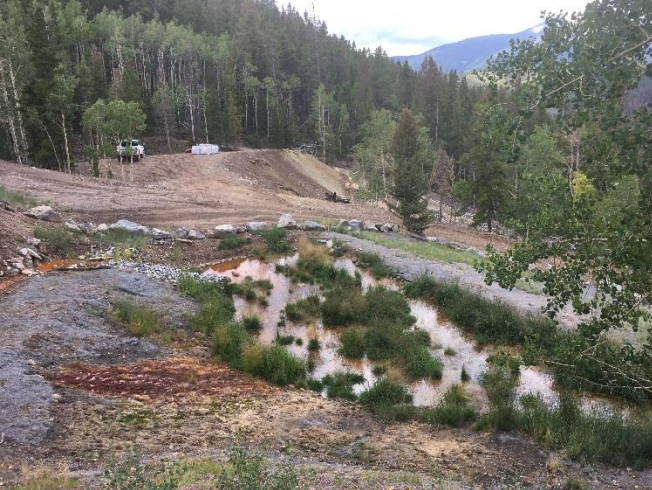
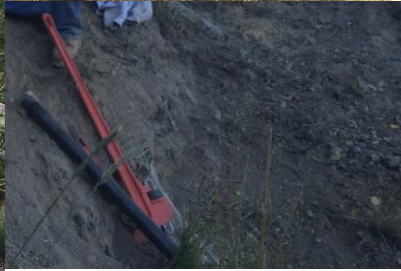
Measuring Potential Releases – Site Characterization

- ✦ Minnie Lynch Mine
- ✦ Initial Design: adit stabilization
- ✦ 2nd step: Gather groundwater data behind adit through fabricated wells
 - 2 wells showed 12-14' of head behind collapse
- ✦ Final Design: French drain outside of collapse to collect surface and ground water.
- ✦ Replaced dysfunctional sediment pond with wetland
